**Flood Control Project Maintenance  
Levee Inspections**

**Fall 2011 Levee Maintenance Deficiency Summary Report**

**Levee Inspection Report By Mile - Fall 2011**

**City of Sacramento**

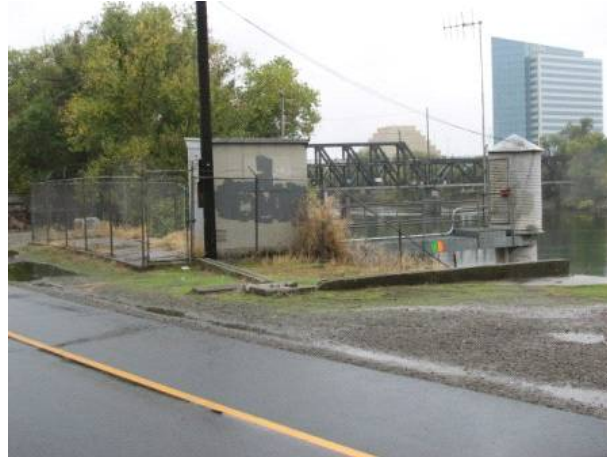
Levee Mile Report Line	1
Start Levee Mile	0.14
End Levee Mile	0.14
Location	Water Side
Category	Earthen Levee
Item	Encroachments

View of the I Street recorder can.

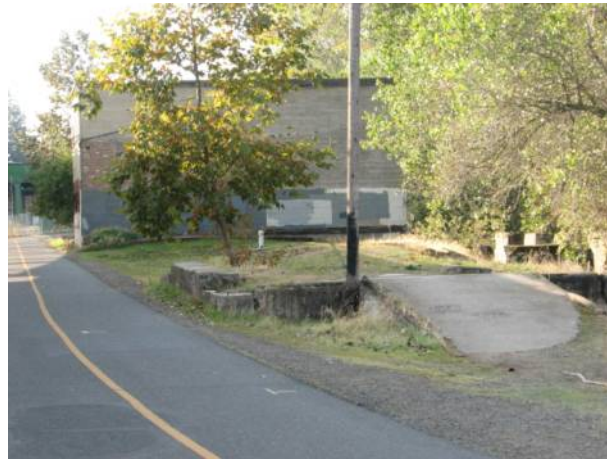
Levee Mile Report Line	2
Start Levee Mile	0.16
End Levee Mile	0.16
Location	Water Side
Category	Earthen Levee
Item	Encroachments

Historical Building with foundations and ramps on upstream and downstream sides. Fall 2011

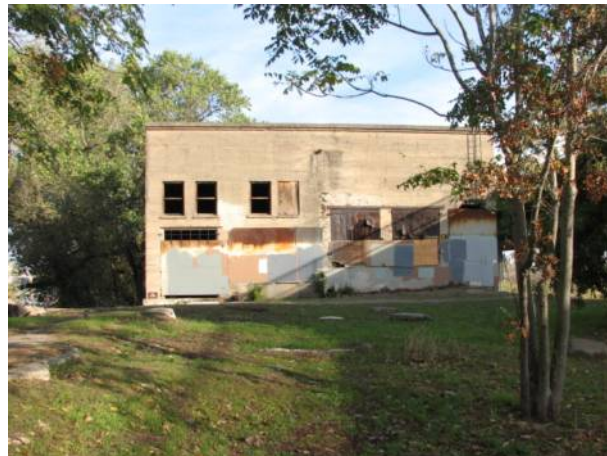
Levee Mile Report Line	2
Start Levee Mile	0.16
End Levee Mile	0.16
Location	Water Side
Category	Earthen Levee
Item	Encroachments

A view of the south side of the building. Fall 2011

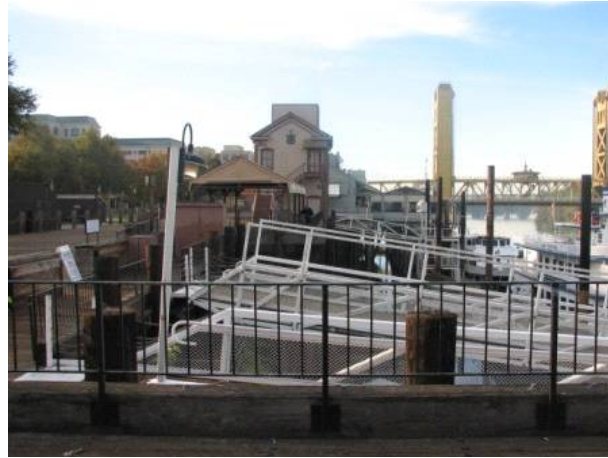
Levee Mile Report Line	3
Start Levee Mile	0.37
End Levee Mile	0.73
Location	Crown
Category	Earthen Levee
Item	Encroachments

Photo looking downstream from the Delta King in Old Sacramento.

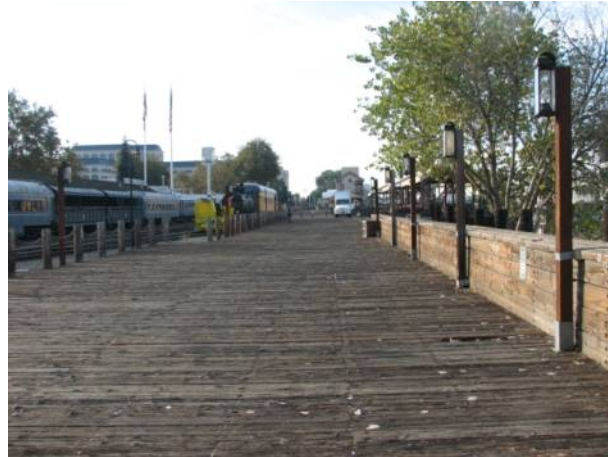
Levee Mile Report Line	3
Start Levee Mile	0.37
End Levee Mile	0.73
Location	Crown
Category	Earthen Levee
Item	Encroachments

The wooden board walk in Old Sacramento on top of the flood wall. Fall 2011

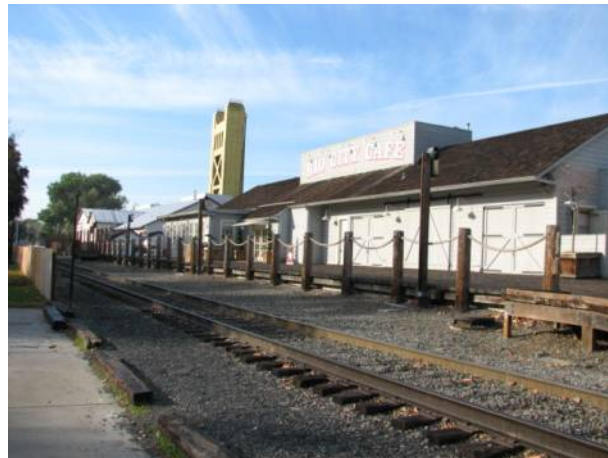
Levee Mile Report Line	3
Start Levee Mile	0.37
End Levee Mile	0.73
Location	Crown
Category	Earthen Levee
Item	Encroachments

The buildings are on top of the flood wall and extend out over the river. Fall 2011

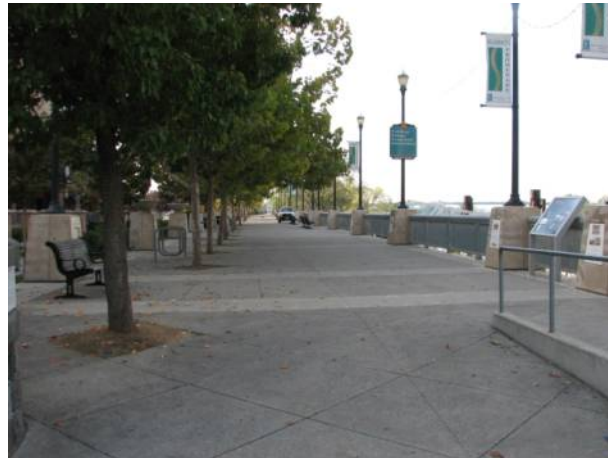
Levee Mile Report Line	4
Start Levee Mile	0.76
End Levee Mile	1.15
Location	Crown
Category	Earthen Levee
Item	Encroachments
The start of the river walk at Tower Bridge. Fall 2011	
johngw_f_20111109_537.jpg

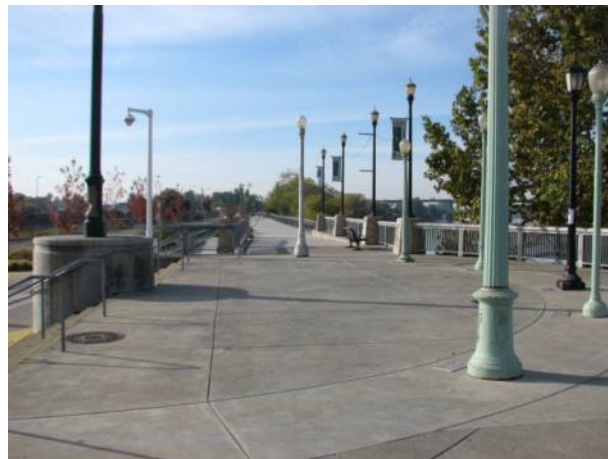
Levee Mile Report Line	4
Start Levee Mile	0.76
End Levee Mile	1.15
Location	Crown
Category	Earthen Levee
Item	Encroachments
The start of the newest extension of the river walk. Fall 2011	
johngw_f_20111109_538.jpg

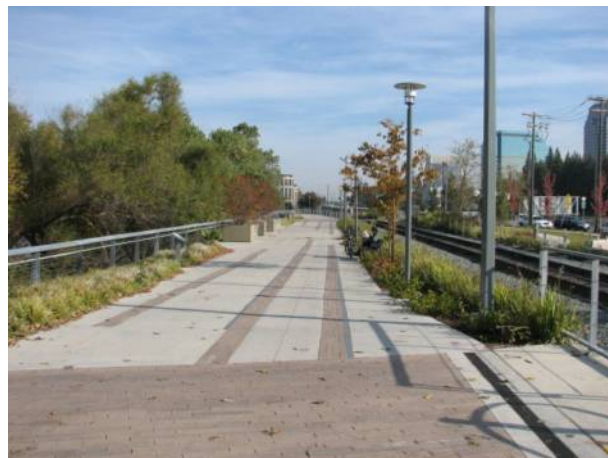
Levee Mile Report Line	4
Start Levee Mile	0.76
End Levee Mile	1.15
Location	Crown
Category	Earthen Levee
Item	Encroachments
The end of the river walk. This is where the bike trails turns off the levee. Fall 2011	
johngw_f_20111109_539.jpg

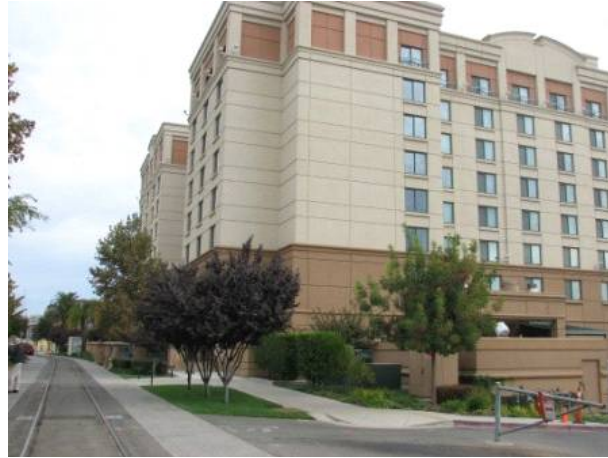
Levee Mile Report Line	5
Start Levee Mile	0.78
End Levee Mile	0.78
Location	Crown
Category	Earthen Levee
Item	Encroachments

Embassy Suites

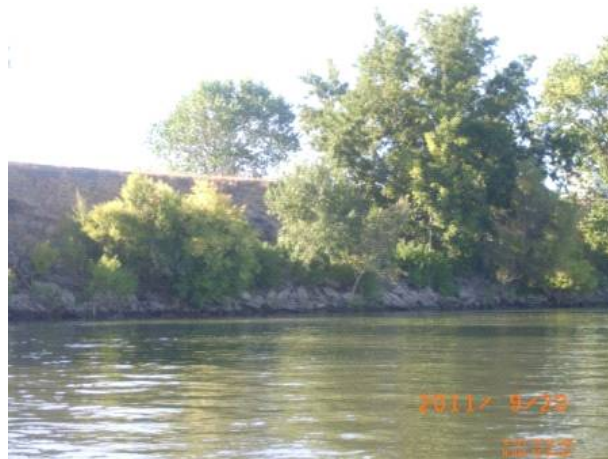
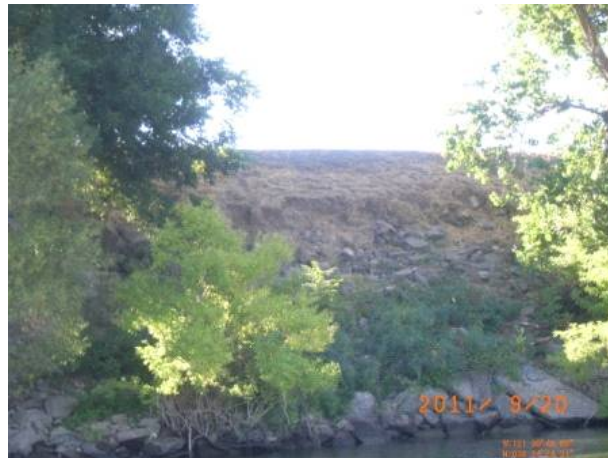
Levee Mile Report Line	6
Start Levee Mile	1.25
End Levee Mile	1.39
Location	Water Side
Category	Supplemental
Item	USACE Erosion Survey

6	1.25	1.39	Supplemental	USACE Erosion Survey	WS	M	Inspector Comments: 2008 - Oversized levee, should be repaired under maintenance. 2009 - Shallow slumps at the mid bank. 2010 - Some minor erosion at the toe, likely from wave wash. Some new shallow slumps. 2011: One new tree has fallen. [2011 Site ID: SAC_58-5_L]	38.573069 ° -121.512166 °	38.572277 ° -121.513063 °	11 Y
7	1.38	1.38	Earthen Levee	Encroachments	CR	W	Equipment Inspector Comments: The two box cars have now replace the sheds. Since the last inspection two more box cars have been added. The total is four now.	38.572320 ° -121.512668 °	38.572320 ° -121.512668 °	3 Y
8	1.41	1.41	Earthen Levee	Encroachments	WS	W	Pipe	38.572008 ° -121.513017 °	38.572008 ° -121.513017 °	5 Y
9	1.46	1.46	Earthen Levee	Encroachments	CR	W	Equipment Inspector Comments: The trains have been moved upstream to this new location.	38.571477 ° -121.513744 °	38.571477 ° -121.513744 °	9 Y

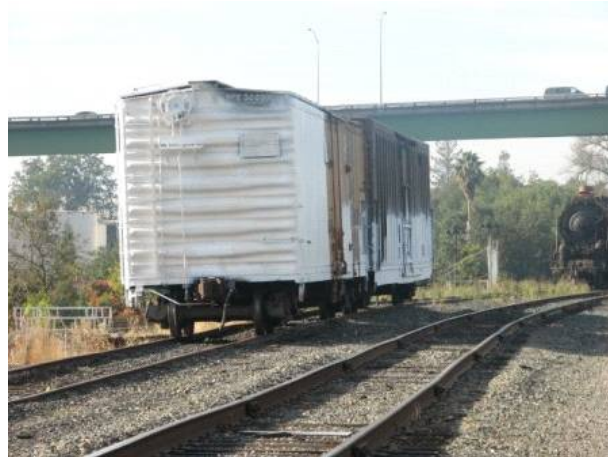
Levee Mile Report Line	7
Start Levee Mile	1.38
End Levee Mile	1.38
Location	Crown
Category	Earthen Levee
Item	Encroachments

This is the replacement of the storage bins on the railroad tracks.

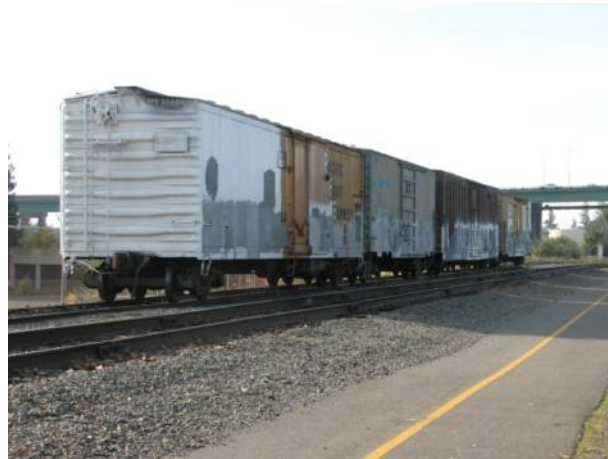
Levee Mile Report Line	7
Start Levee Mile	1.38
End Levee Mile	1.38
Location	Crown
Category	Earthen Levee
Item	Encroachments

There have been an additional two box cars added to this area. Fall 2011

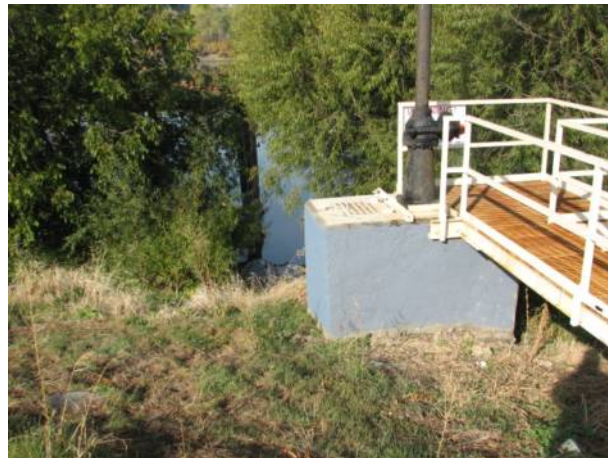
Levee Mile Report Line	8
Start Levee Mile	1.41
End Levee Mile	1.41
Location	Water Side
Category	Earthen Levee
Item	Encroachments

The screw gate is the positive closure for the pipe. Fall 2011

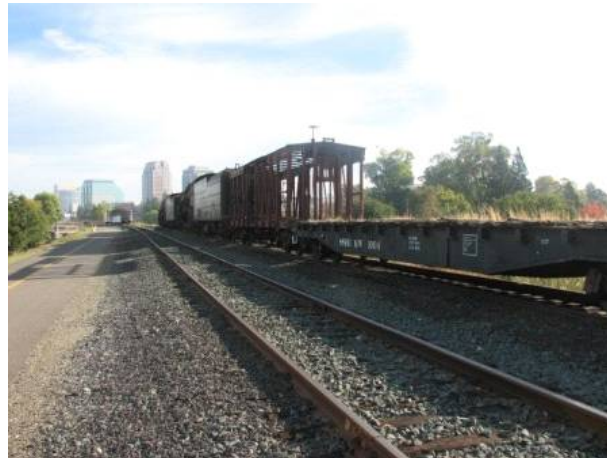
Levee Mile Report Line	9
Start Levee Mile	1.46
End Levee Mile	1.46
Location	Crown
Category	Earthen Levee
Item	Encroachments
<p>The trains that were at 1.54 have been pulled upstream to this location. The CVFPB has asked that they be removed from the levee.</p>	
<p>johngw_f_20111007_192.jpg</p>

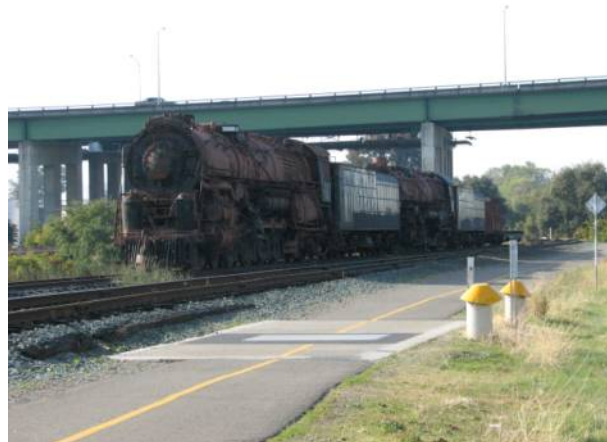
Levee Mile Report Line	9
Start Levee Mile	1.46
End Levee Mile	1.46
Location	Crown
Category	Earthen Levee
Item	Encroachments
<p>The two steam engines and other cars are stored on the levee. There is an agreement being worked on with the Railroad Museum and the City. This is to have the cars moved when necessary. Fall 2011</p>	
<p>johngw_f_20111109_542.jpg</p>

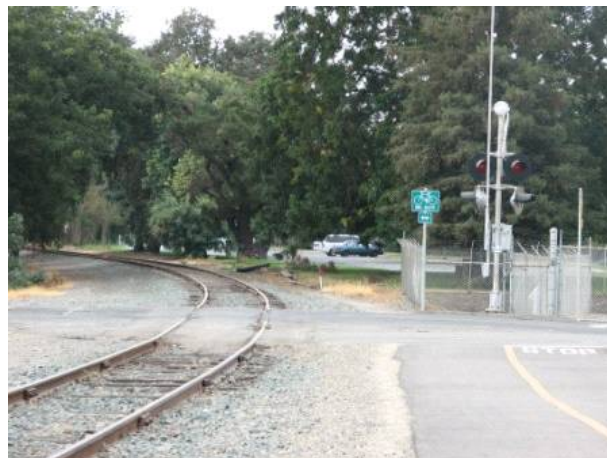
10	1.73	1.96	Earthen Levee	Encroachments	CR	W	Equipment Inspector Comments: Levee is oversized with railroad tracks and paved parking. This area is Miller Park.	38.568172 ° -121.516042 °	38.564882 ° -121.516265 °	6 Y
11	1.75	1.75	Earthen Levee	Encroachments	CR	W	Pipe	38.567821 ° -121.516091 °	38.567821 ° -121.516091 °	144 Y
12	1.96	2.34	Earthen Levee	Encroachments	CR	W	Equipment Inspector Comments: Railroad tracks run on crown of levee, paved roadway runs along toe on waterside. This is Miller Park Marina area.	38.564900 ° -121.516253 °	38.559460 ° -121.515085 °	7 Y
13	2.04	2.04	Earthen Levee	Encroachments	CR	W	Pipe Inspector Comments: The pipe has been repaired by the LMA. The pipe was installed by the Railroad Museum and is in talks with the CVFPB. No permit was issued for them.	38.563720 ° °	-121.515890 ° °	145 °

Levee Mile Report Line	10
Start Levee Mile	1.73
End Levee Mile	1.96
Location	Crown
Category	Earthen Levee
Item	Encroachments
<p>Miller Park at Broadway, railroad track and parking area on levee.</p>	
<p>johngw_f_20111007_189.jpg</p>

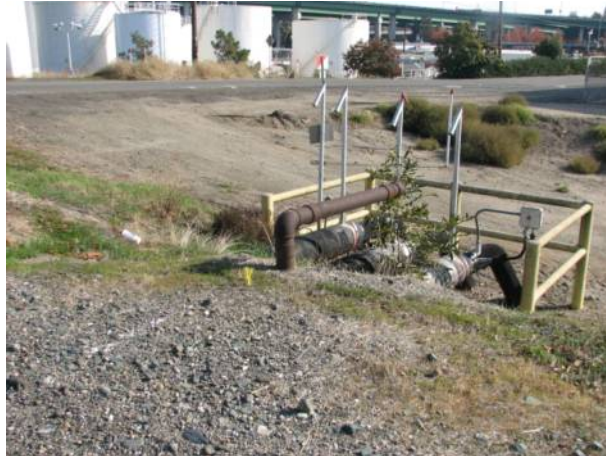
Levee Mile Report Line	11
Start Levee Mile	1.75
End Levee Mile	1.75
Location	Crown
Category	Earthen Levee
Item	Encroachments
A pipe on the landside shoulder crosses under the railroad tracks. Fall 2011	
johngw_f_20111109_543.jpg

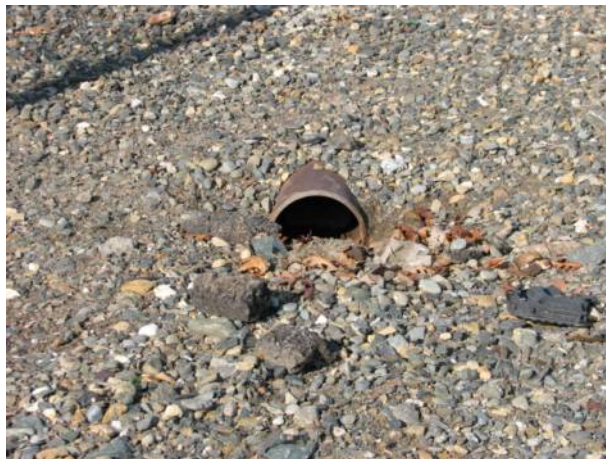
Levee Mile Report Line	11
Start Levee Mile	1.75
End Levee Mile	1.75
Location	Crown
Category	Earthen Levee
Item	Encroachments
This appears to be a drain pipe under a driveway. It is a different pipe then the other photo for this issue. Fall 2011	
johngw_f_20111109_544.jpg

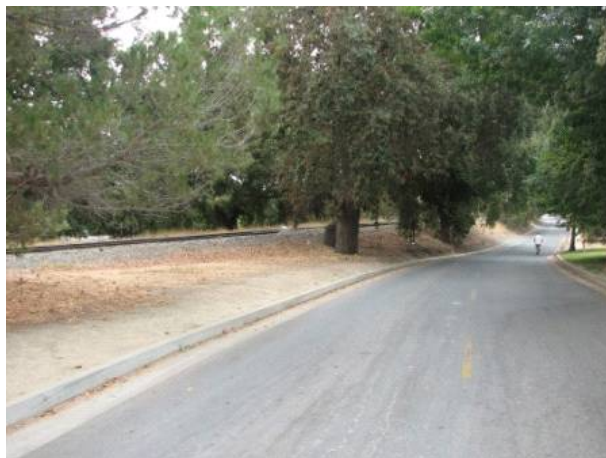
Levee Mile Report Line	12
Start Levee Mile	1.96
End Levee Mile	2.34
Location	Crown
Category	Earthen Levee
Item	Encroachments
Railroad tracks are on levee crown. The street is to the boat ramp.	
johngw_f_20111007_190.jpg

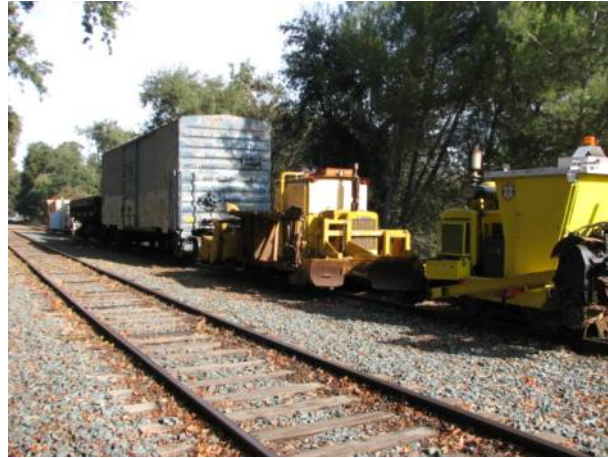
Levee Mile Report Line	12
Start Levee Mile	1.96
End Levee Mile	2.34
Location	Crown
Category	Earthen Levee
Item	Encroachments

The Railroad museum has moved the trains to this area along Miller Park. Fall 2011

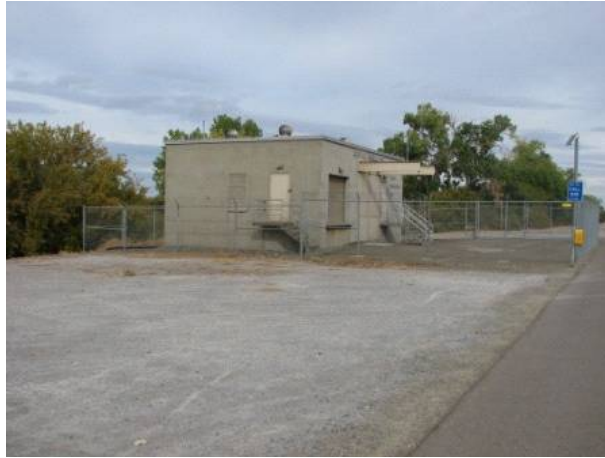
Levee Mile Report Line	16
Start Levee Mile	2.90
End Levee Mile	2.90
Location	Crown
Category	Earthen Levee
Item	Encroachments

City of Sacramento pump station on the waterside of the crown of the levee.
